BEAR POINT MITIGATION BANK PROJECT SITE

FDEP Permit #0175246-001

**Semi-annual Status Report
In Support of Specific Conditions #26 & 29**

January through June, 2020

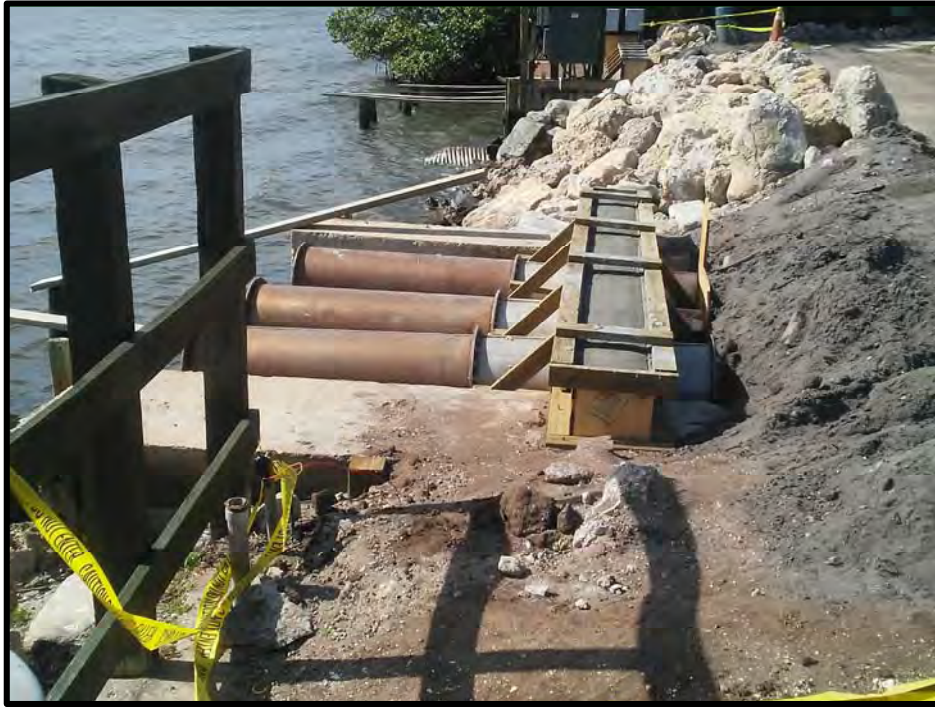
PHOTOGRAPH #01: NEW SHEET PILE WALL TO REPLACE OLD RIP-RAP, UNDER CONSTRUCTION IN JANUARY 2020

in April prior to the pump-up event. This year, as mentioned previously, the riprap around the pimp area was replaced with a sheet pile wall to more efficiently protect the levee during storm events. An area was also added for the public to fish and/or picnic and bird watch. Picnic tables will be added soon, Please refer to **Exhibit E** for yearly maintenance activities and associated costs.

- Construction Condition:** The pumps were removed for maintenance as they are every year. The pump outfall pipes were replaced and the riprap south of and adjacent to the pump station was replaced with a sheet pile wall for further protection of the Bank from hurricane damage. At the same time, an area behind the new sheet pile wall was graded and picnic tables will be added for fishing and wildlife viewing. The pumps have now been re-installed and are functioning properly, and the levees are in good condition.

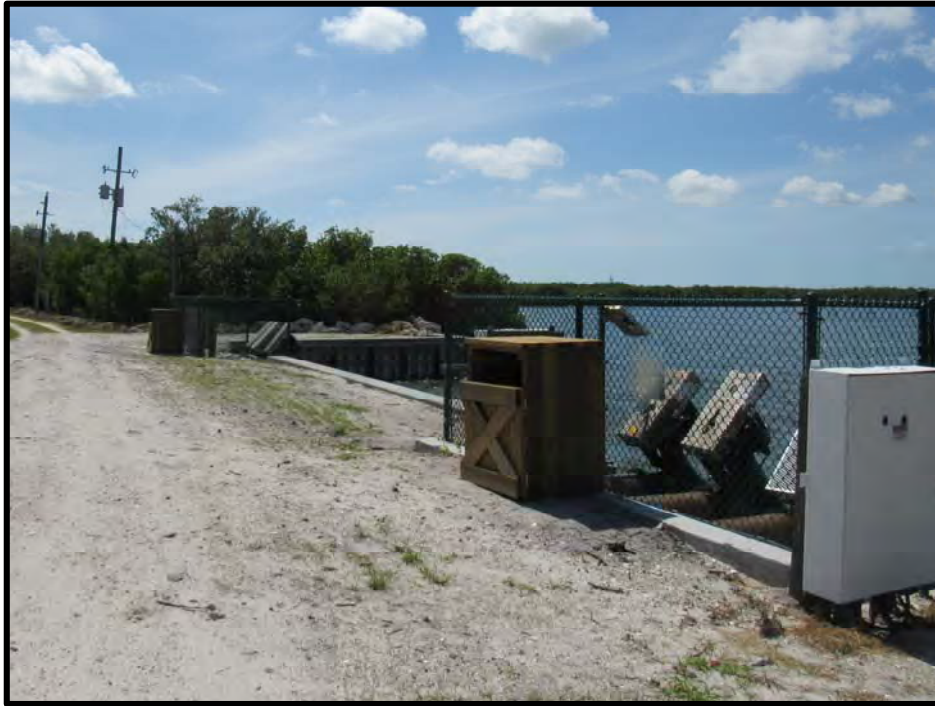
PHOTOGRAPH #02: NEW SHEET PILE WALL AFTER CONSTRUCTION, JUNE 2020

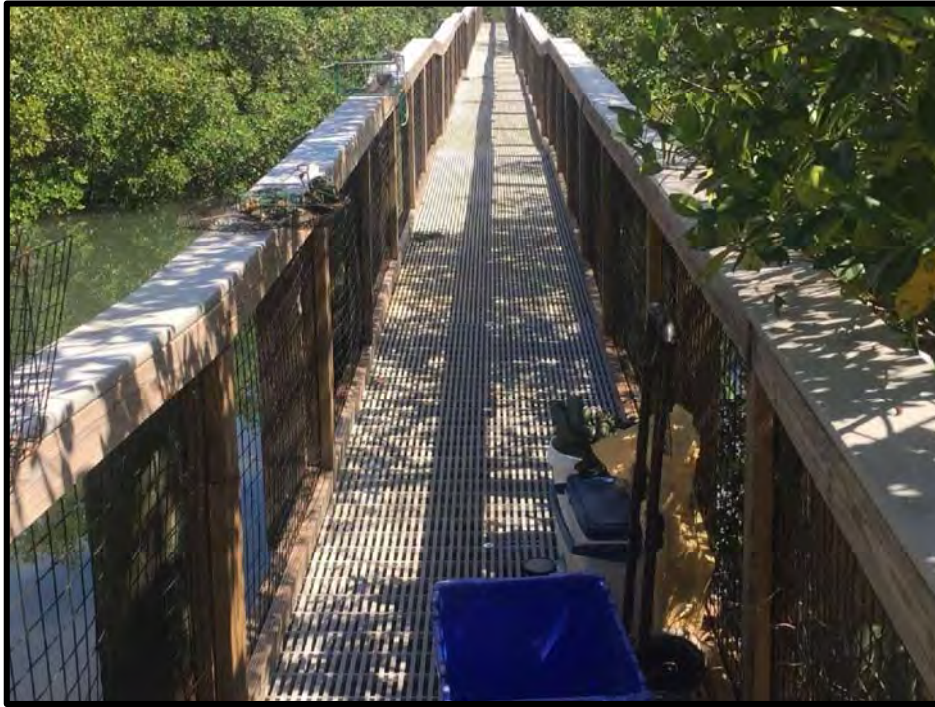
PHOTOGRAPH #05: THE MELILLO BIRD OBSERVATORY IS NOW BEING UTILIZED BY FISHERMEN, BIRD-WATCHERS, AND HIKERS. JANUARY 2020

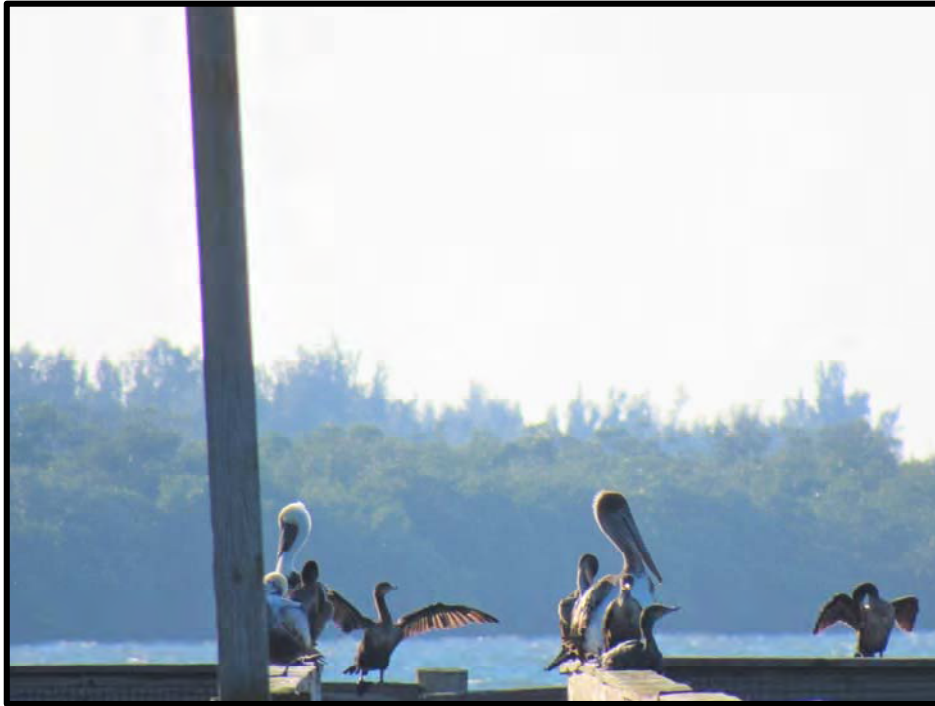
PHOTOGRAPH #06: THE TRAUB DOCK CONTINUES TO PROVIDE VALUABLE ROOSTING HABITAT TO SEVERAL AVIAN SPECIES. FEBRUARY 2020

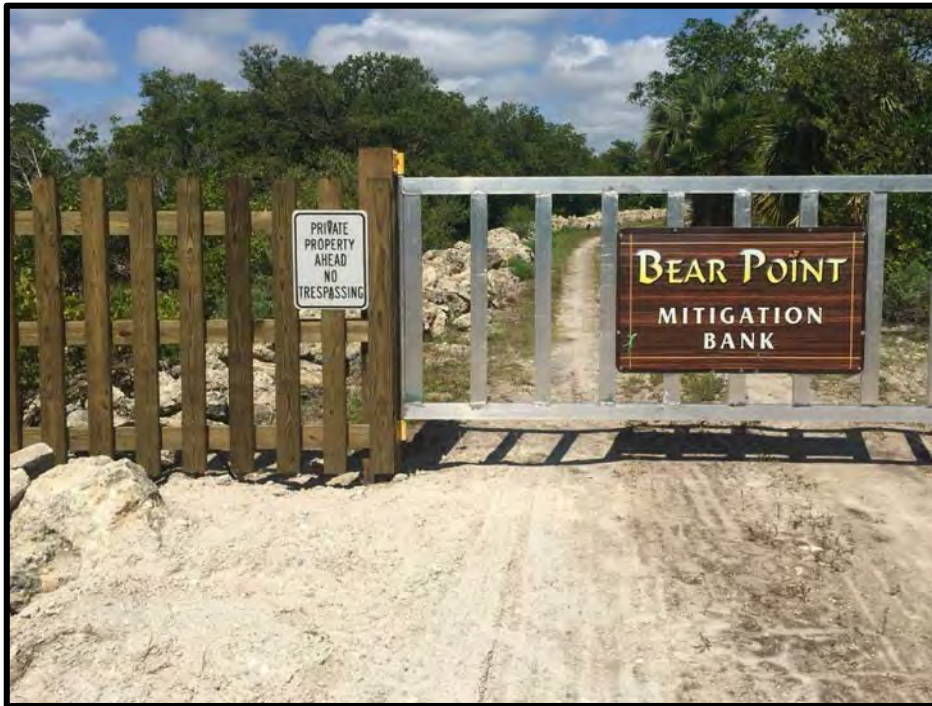
PHOTOGRAPH #10: THE NEW GATE EXTENDS OFF THE ROAD INTO THE ROCKS, KEEPING CYCLISTS AND PEDESTRIANS OUT OF THE MITIGATION BANK.

Inspections of docks, culverts, levee, trash receptacles, gates and signage were performed and status recorded in the monthly inspection reports. A new gate was installed at the entrance to the Bank to keep out people and bicycles from entering the mitigation bank area. This was predicated by a robbery of one of the houses at the north end of the Bank. Additional details about the culverts and levee can be found in **Exhibit B**.
