St. Lucie County Artificial Reef Monitoring Program

Civic Center Reef — **2nd Annual Monitoring**

Bob Herbst, Jr. Reef — **1st Annual Monitoring**

**2nd Annual Monitoring of the Civic Center Reef
Deployed in Jan-Feb 2007**

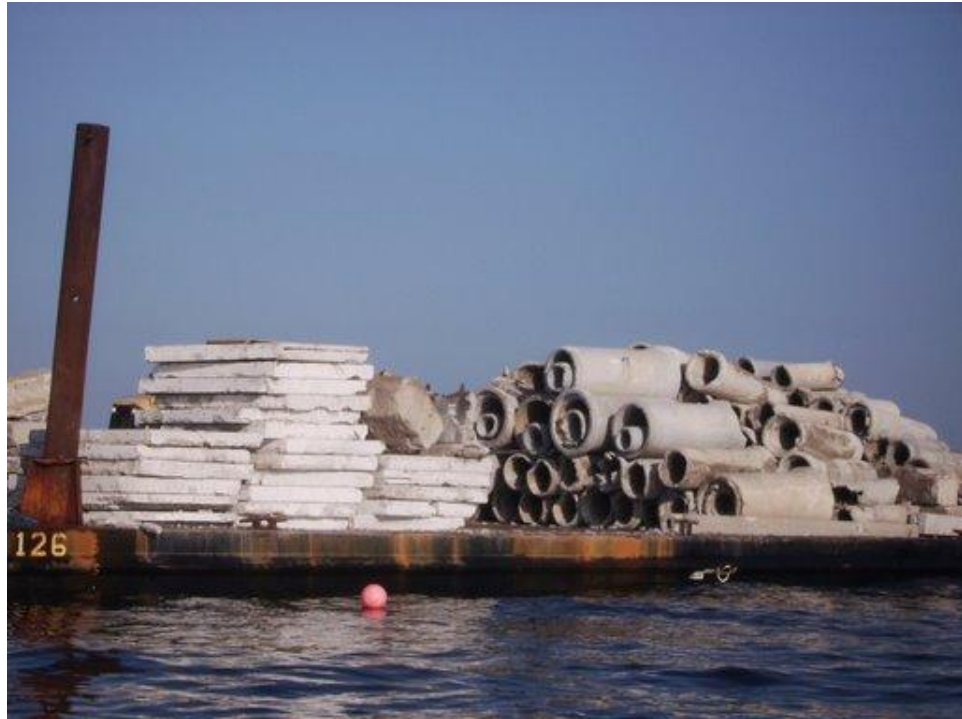
Figure 2 Barge load of materials prior to deployment 8/27/08 – slabs, culverts and large chunks.

On August 27, 2008, 630 tons of concrete materials were deployed in 55 ft. of water in the NE section of site #2 to begin the Bob Herbst Jr. Reef. This barge load consisted of mostly large slabs and culverts and can be seen on previous page number 6 of this report. The next day on August 28, 2008 another 461 tons of mixed concrete materials, including a large number of concrete pilings, and some railroad ties were added and placed directly on top of the previous deployment. This second barge load of materials can be seen in the photo on page 6 of this report.

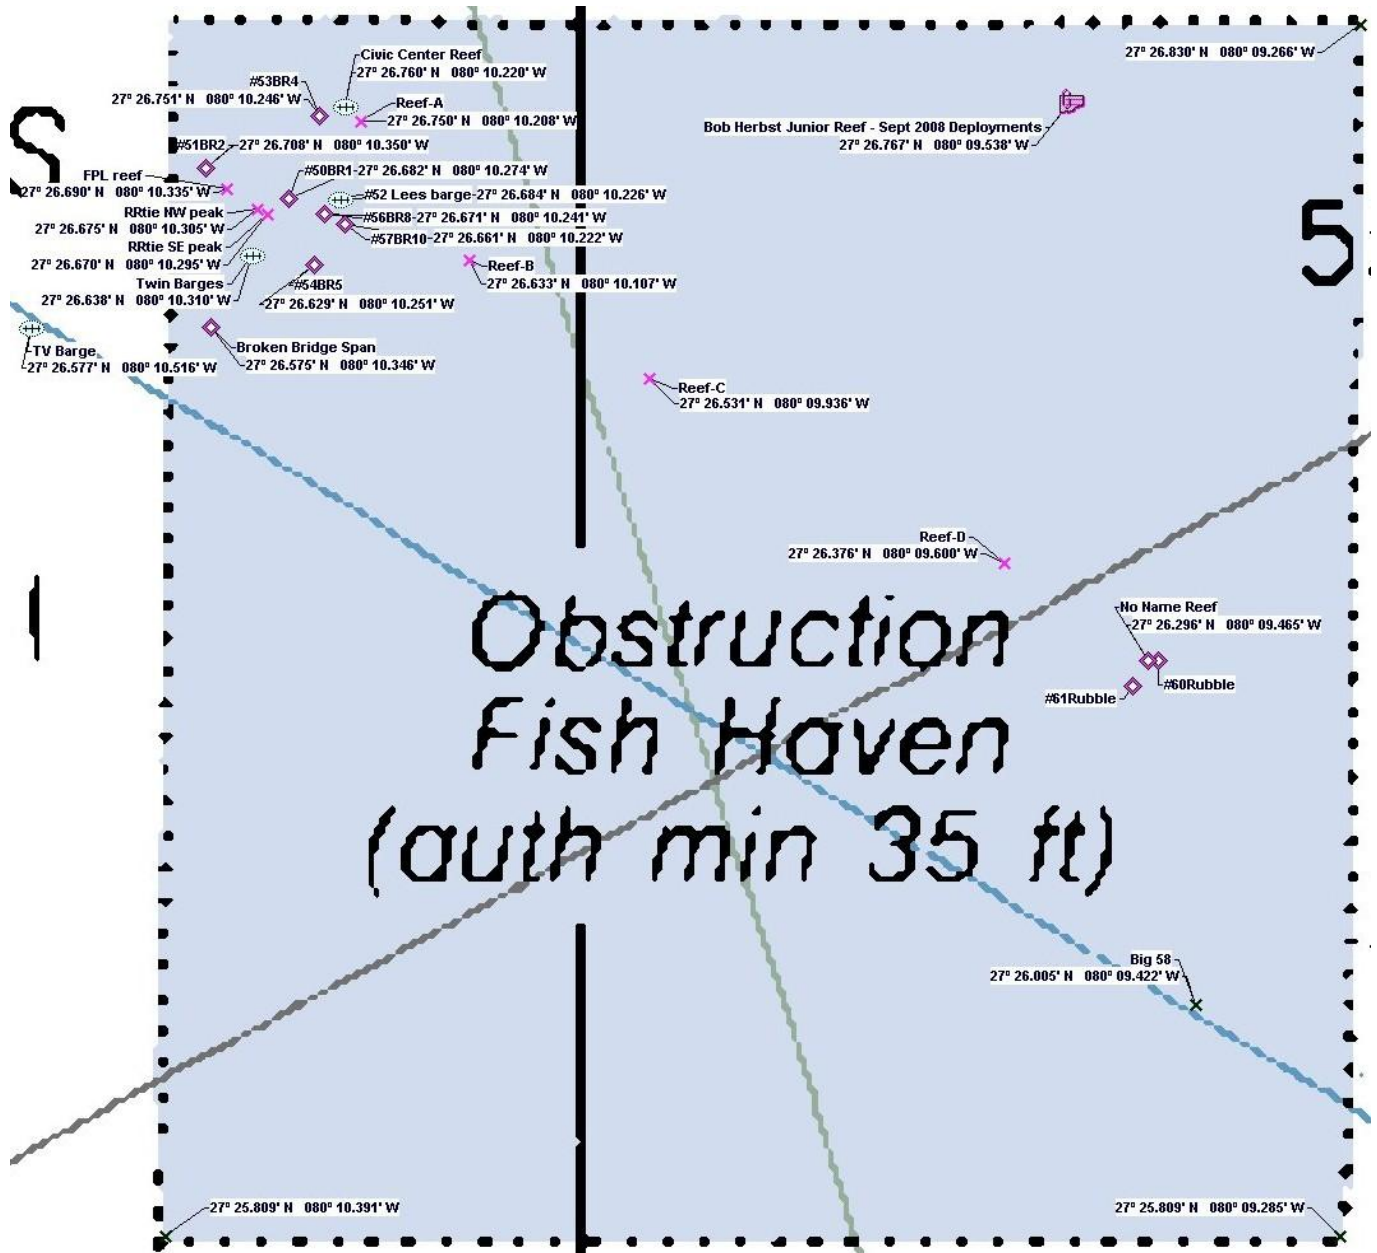
The locations of the Civic Center and Bob Herbst, Jr. reefs are shown on the chart in Figure 4 and on the enlarged NW chart section of Figure 5. These artificial reefs were developed as follows:

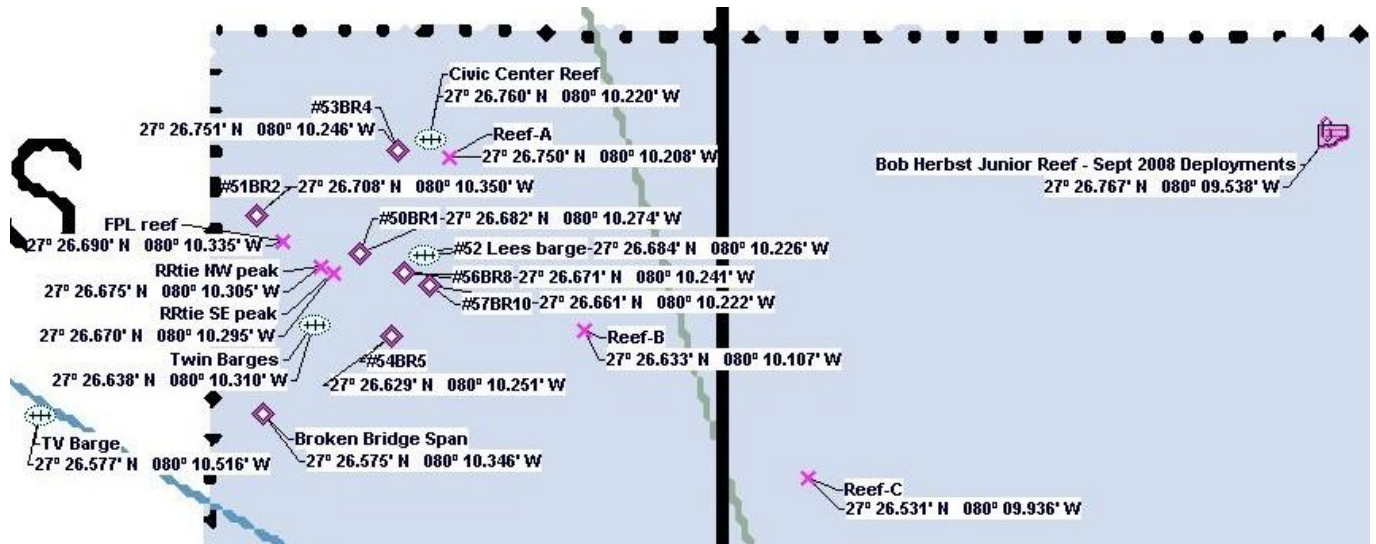
Figure 5 Chart of NW Portion of St. Lucie County Nearshore Artificial Reef Site #2

Table 1 summarizes all of the known artificial reef sites in the St. Lucie County Nearshore Reef Site #2. Figure 5 shows an enlarged chart of the NW corner of Site #2.

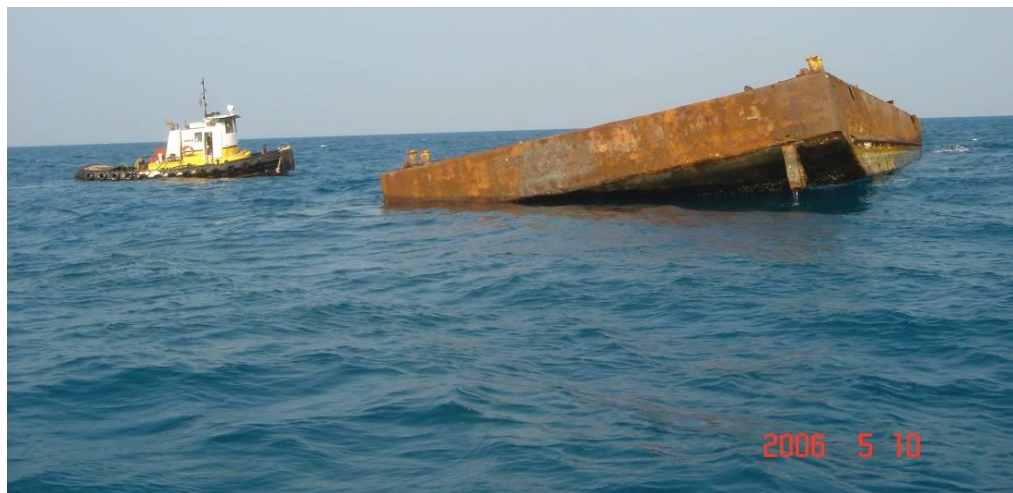
Figure 6 Sterling Barge Deployment

The Sterling Barge was deployed beginning on May 10, 2006 (Figure 6) but ended up resting on her side. On May 15, 2006 she was righted, but ended up resting upside down on the bottom.

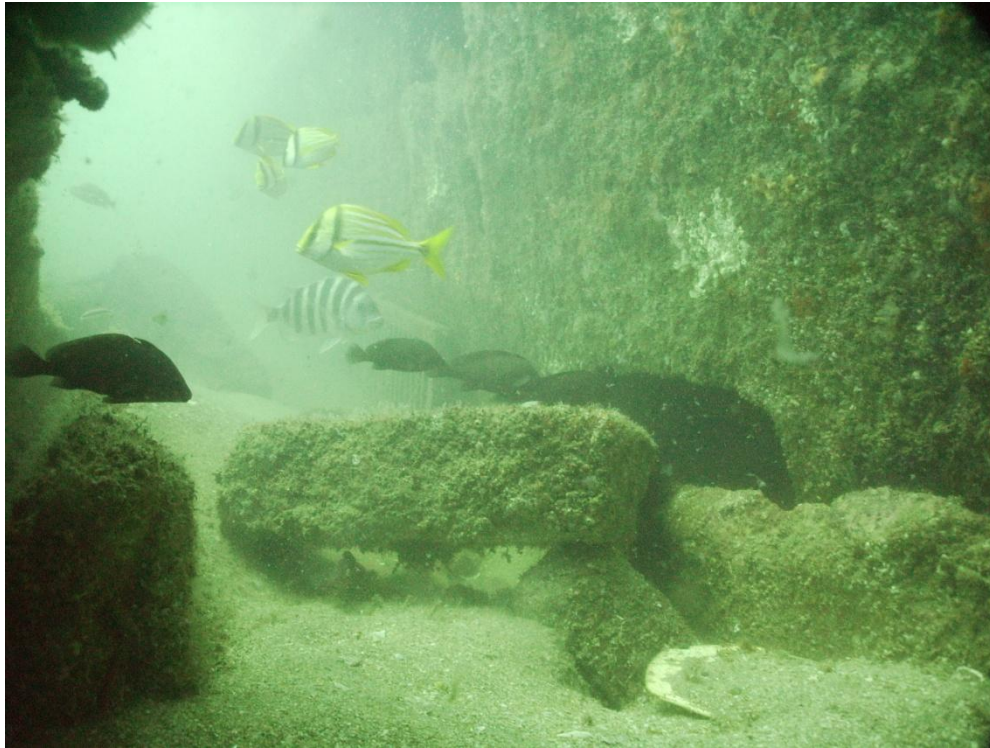
Figure 8 Underwater Photographs of the Civic Center Reef

View from overhang shadowed area with at least five distinct species of fish utilizing shelter.

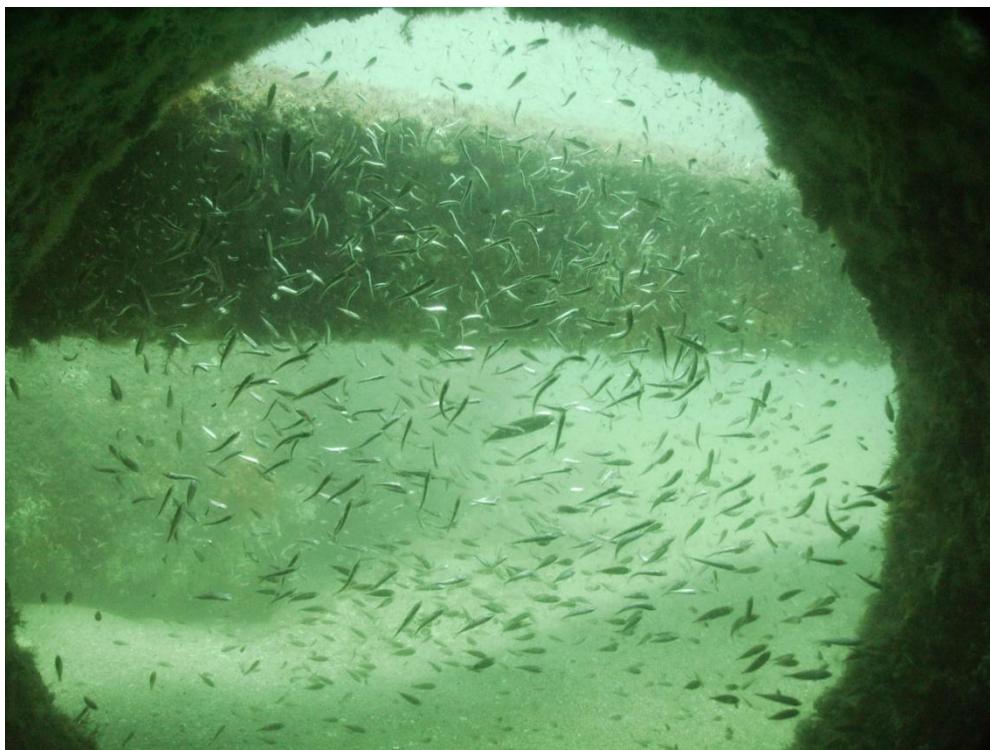
View from inside culvert showing $\frac{3}{4}$ " long fry of an unidentified species.

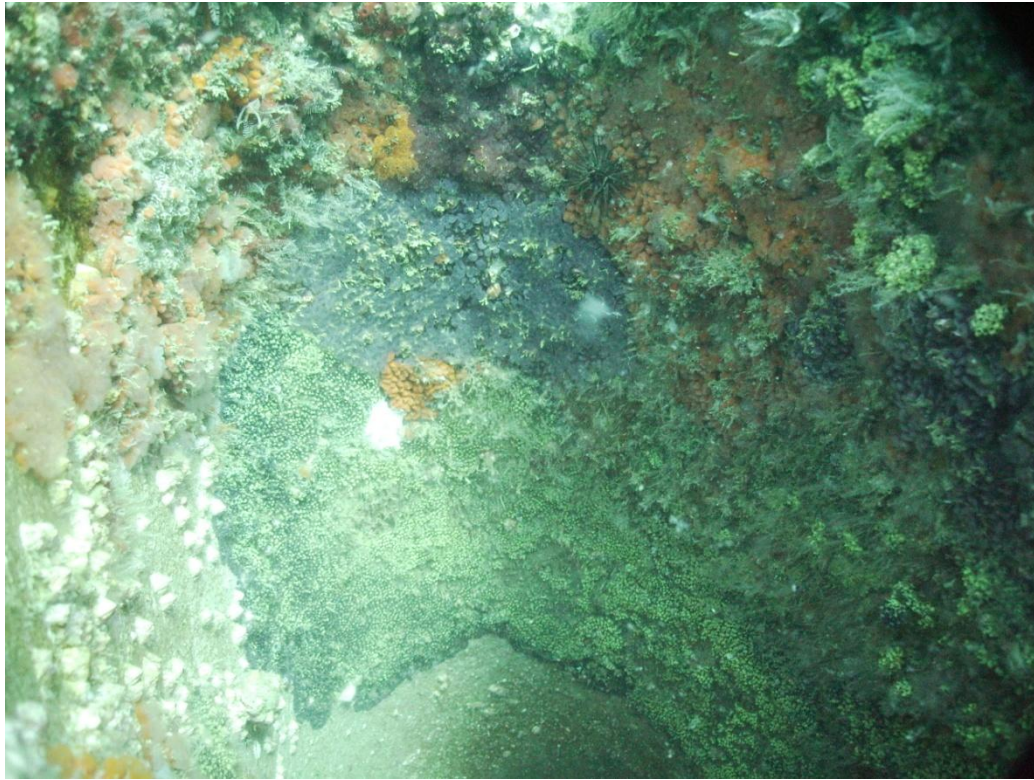
View of the inside of a vertical culvert showing an array of attached benthic organisms.

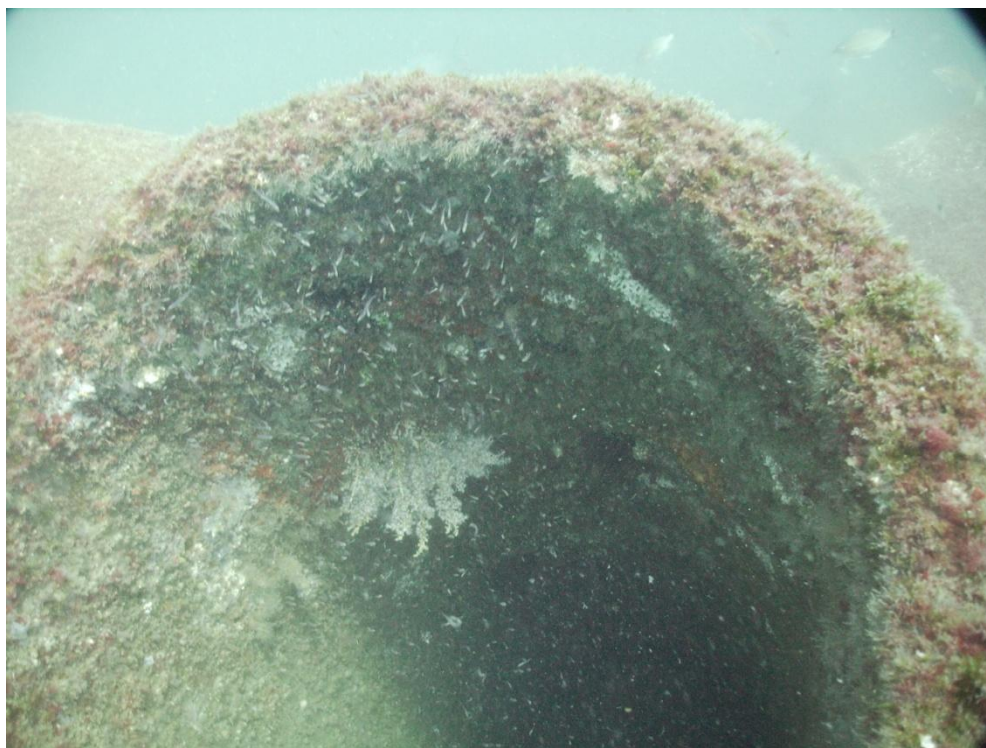
View of the inside of a horizontal culvert with attached soft coral White Telesto,

Carijoa riisei, surrounded by 100's of unidentified species of fry 3/8" long.

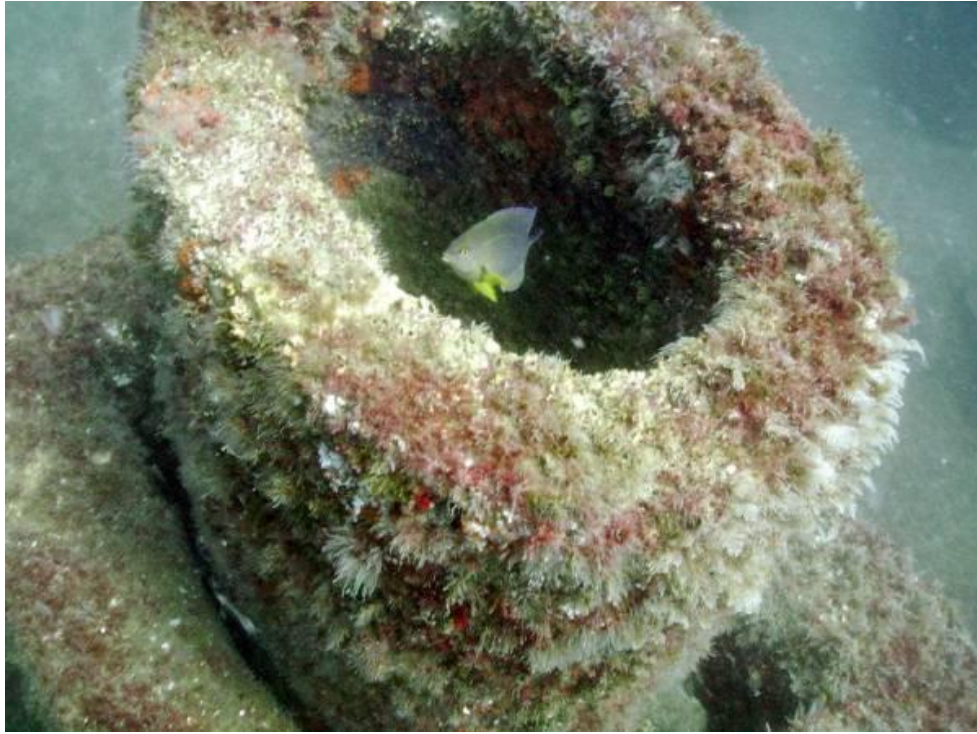
Angelfish taking refuge inside hollow concrete footer.

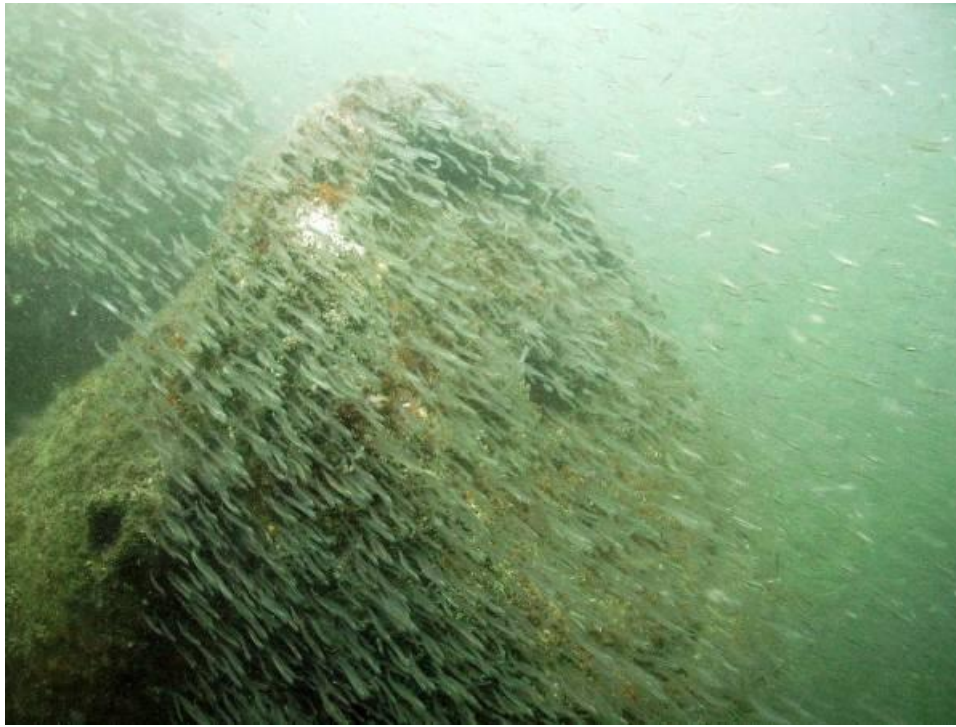
Underwater photographs taken in June 2007, have better visibility than during the 2008 or 2009 monitoring.

Fast swimming school of baitfish during a feeding frenzy.

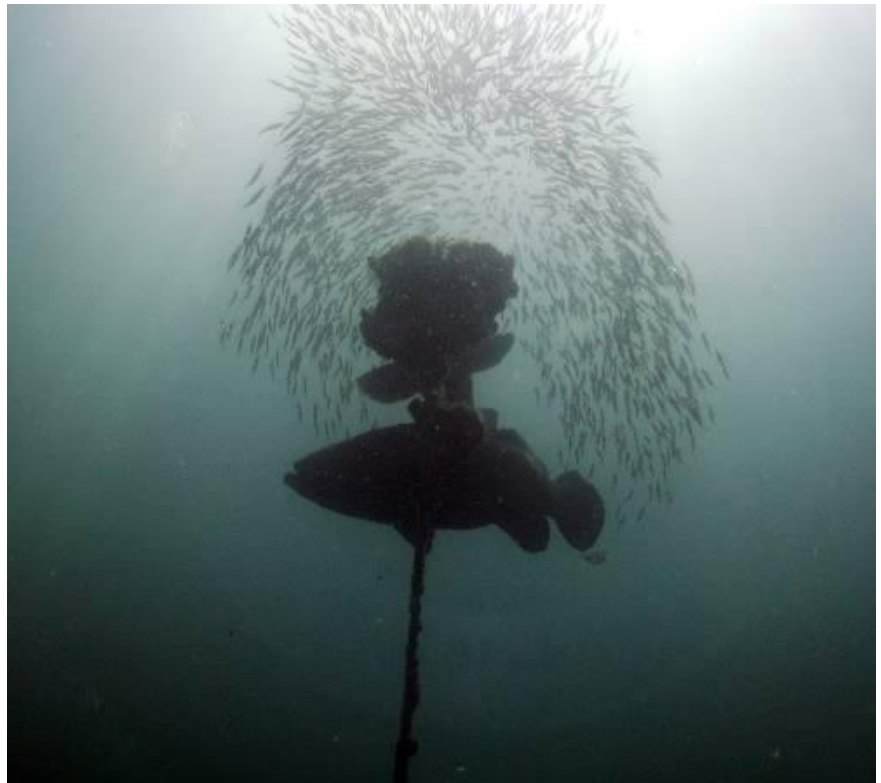
The subsurface buoy located at the southeast end of the Civic Center reef often attracts many different fish species. In this photo a Goliath Grouper and a school of baitfish hover above the active reef.

Snook position themselves around abundant baitfish during a feeding frenzy.

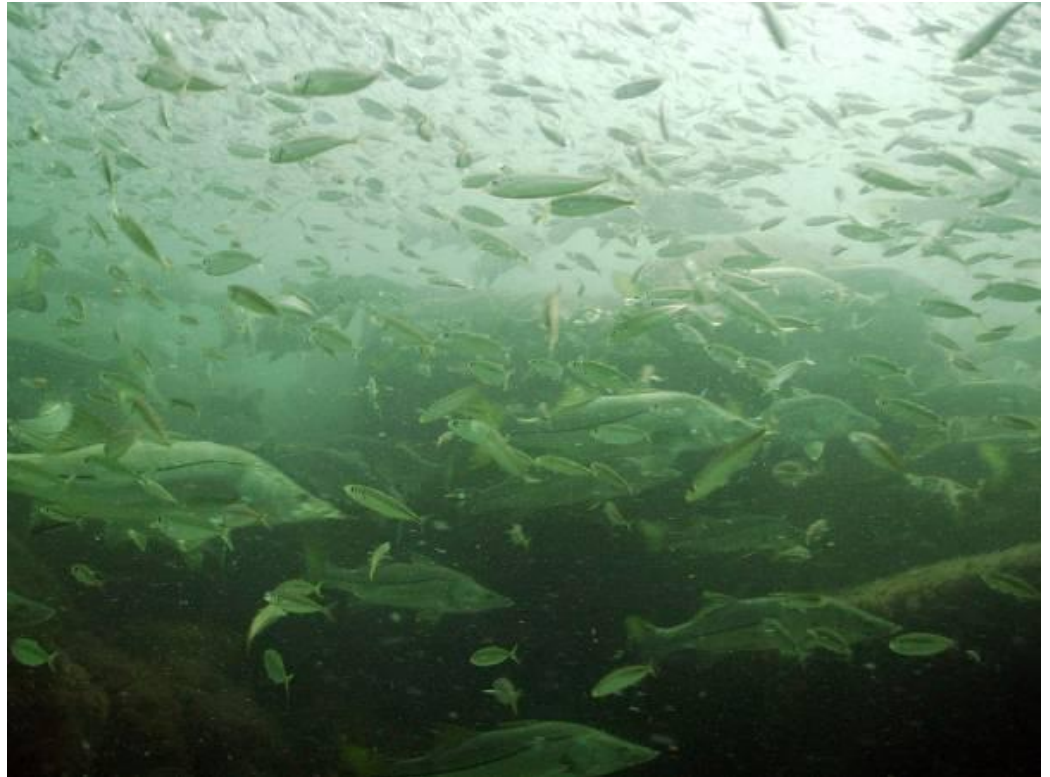
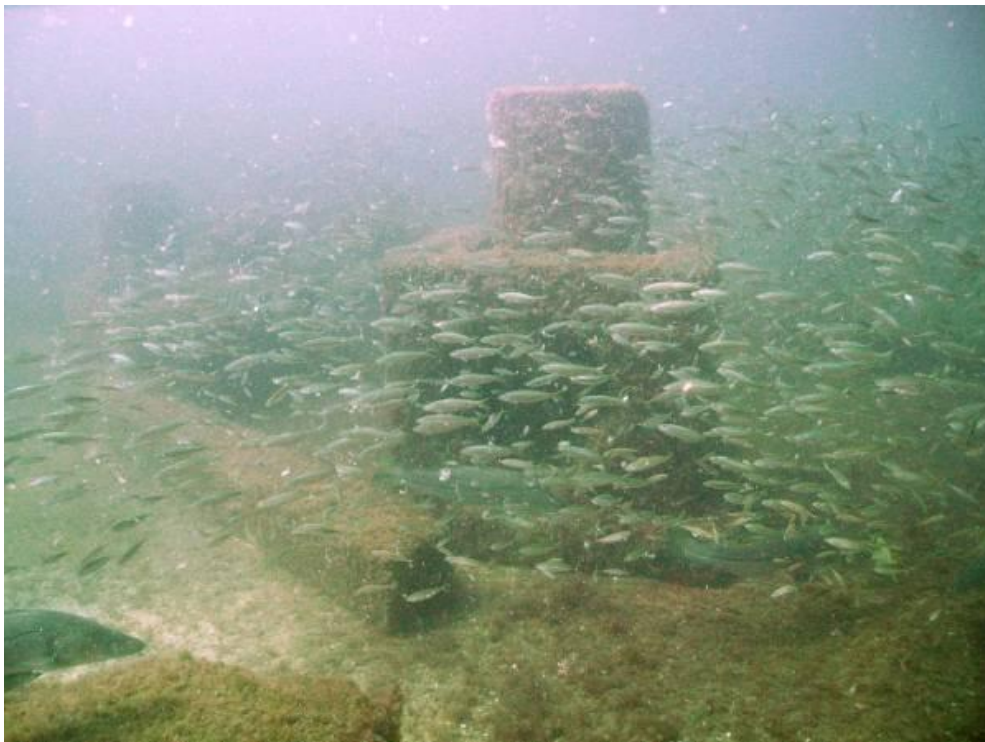
A school of Round Scad baitfish are fast swimming and often ball up with excited predators on the feed.

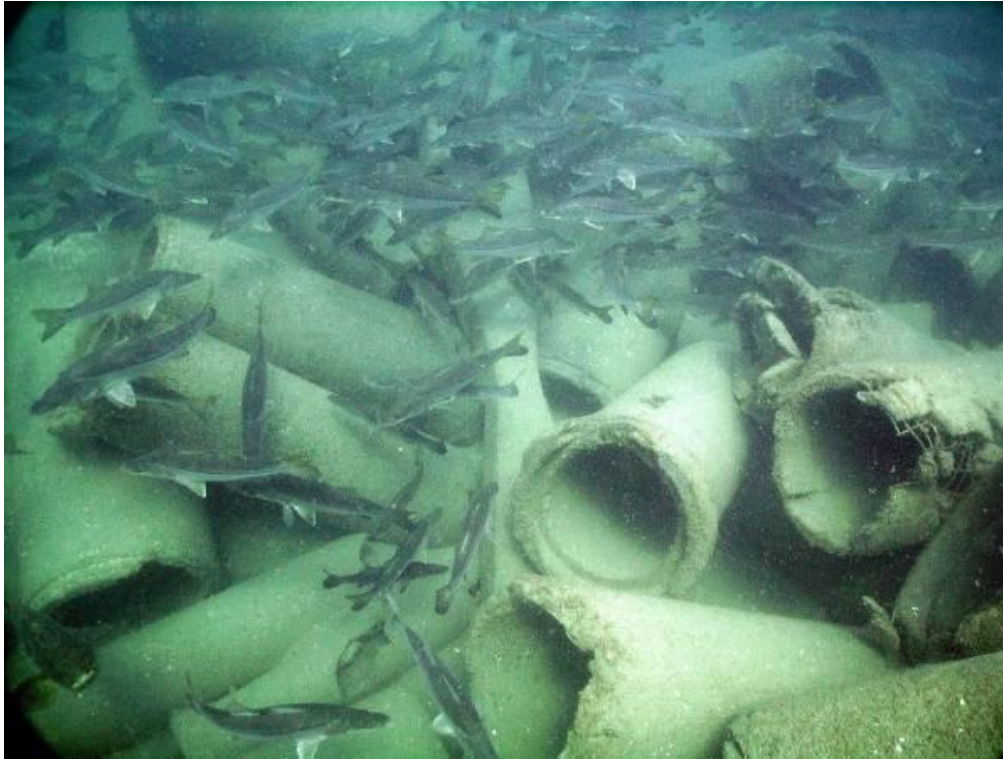
A school of Snook hovering over a pile of concrete culverts.

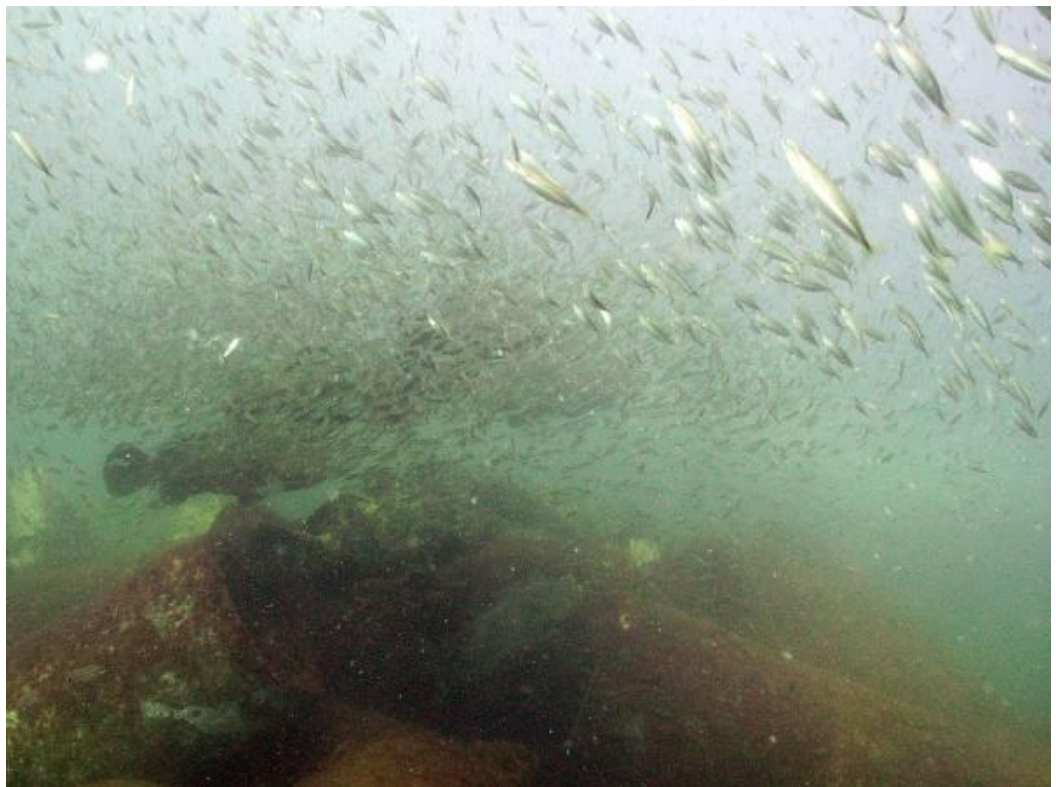
Five Goliath Grouper surrounded by fast swimming school of baitfish, Round Scad.

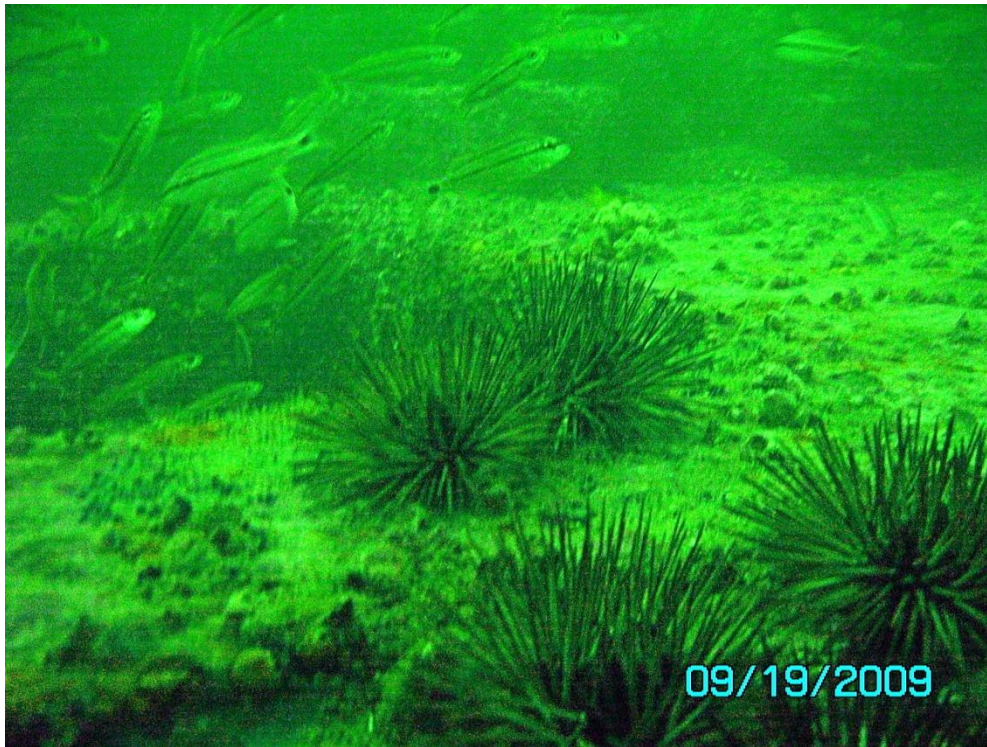
Figure 9 Underwater Photographs of Bob Herbst, Jr. Reef

Sea urchins, barnacles, Tomtates juv. on concrete surfaces of Bob Herbst, Jr. reef.

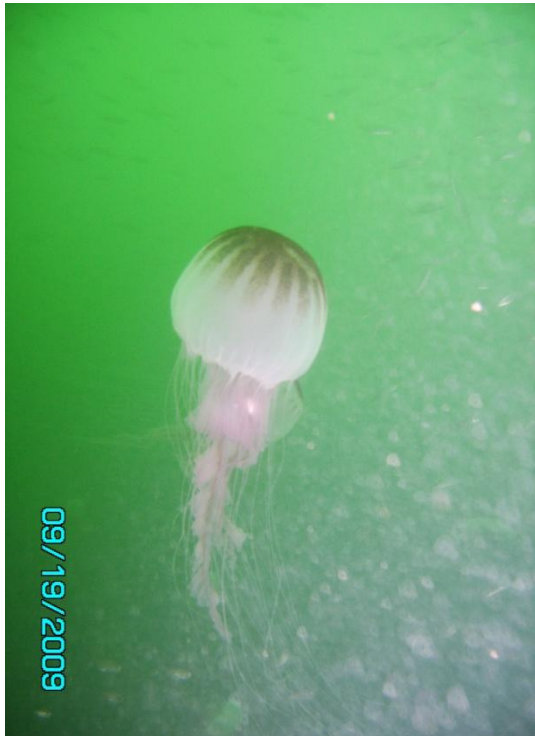
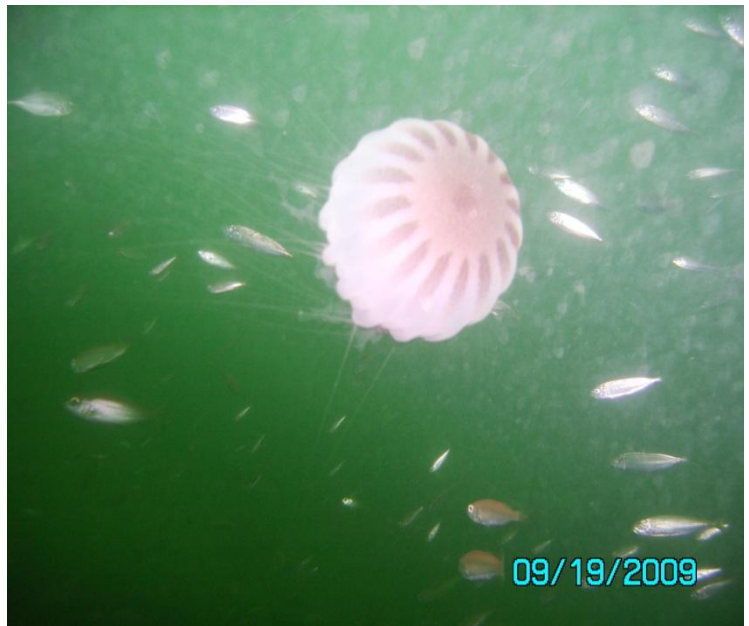
One of 100's of the jellyfish encountered on the Bob Herbst, Jr. reef. Sea Nettles - *Chrysaora quinquecirrha* . Many were seen feeding on baitfish.
