2008 First Annual Monitoring
Civic Center Reef Deployed in Jan-Feb 2007
Offshore St. Lucie County, FL

Prepared for:
St. Lucie County Public Works Department
2300 Virginia Avenue
Fort Pierce, FL 34982-5652

Prepared by:
Lee E. Harris, Ph.D., P.E. and Kerry L. Dillon

2008 First Annual Monitoring of the Civic Center Reef Deployed in Jan-Feb 2007 Offshore St. Lucie County, FL

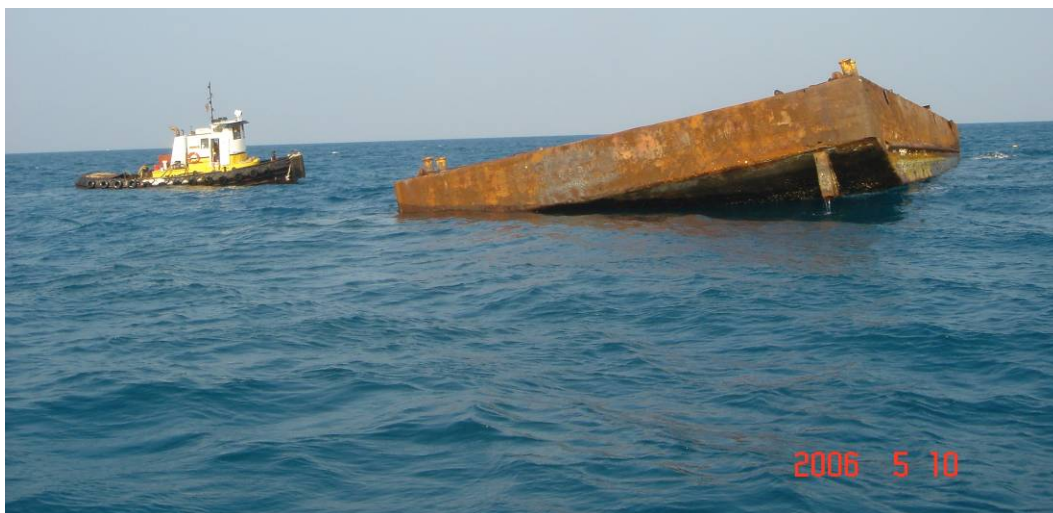
Figure 4. Sterling Barge Deployment

The Sterling Barge was deployed beginning on May 10, 2006 (Figure 4) but ended up resting on her side. On May 15, 2006 she was righted, but ended up resting upside down on the bottom.

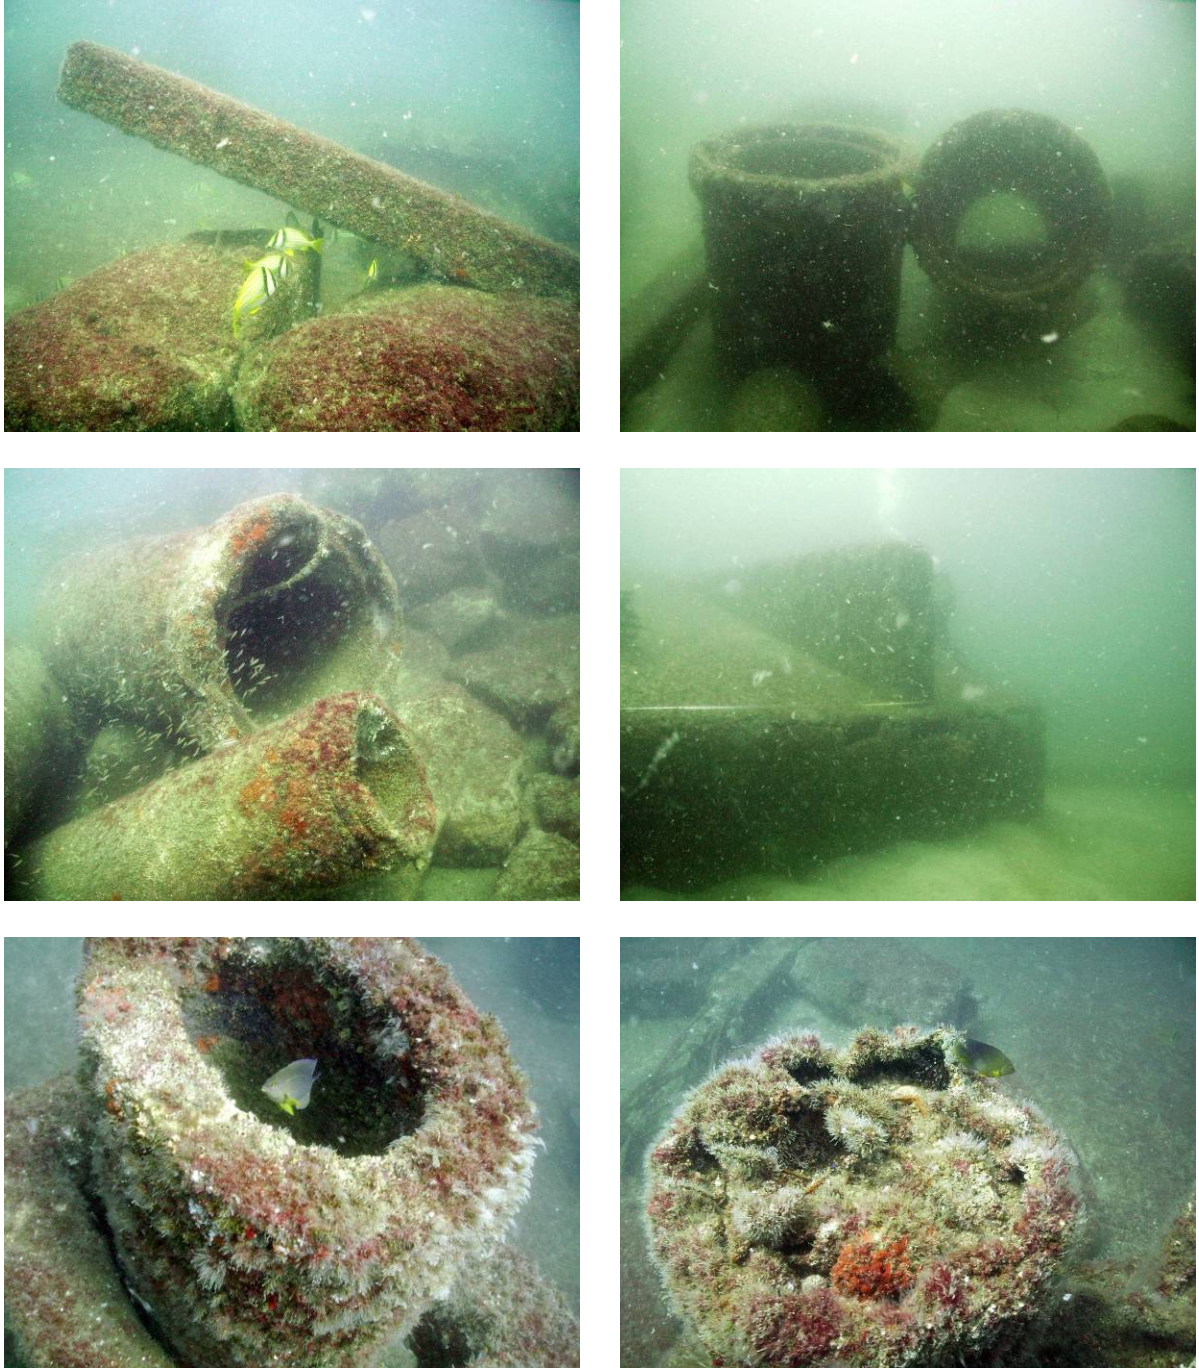
Figure 6. May 2008 Underwater Photographs of Civic Center Reef

Representative underwater photographs of the civic Center Reef taken on May 23, 2008 are shown in Figures 6 and 7. The visibility was fair (30 feet) and the abundance of baitfish often limited visibility. Additional photographs of the reef taken during the summer of 2007 are also available to provide other views of the reef during unusually good visibility (60 feet), so that the summer 2007 photographs clearly show the reef structure with benthic and pelagic marine life.

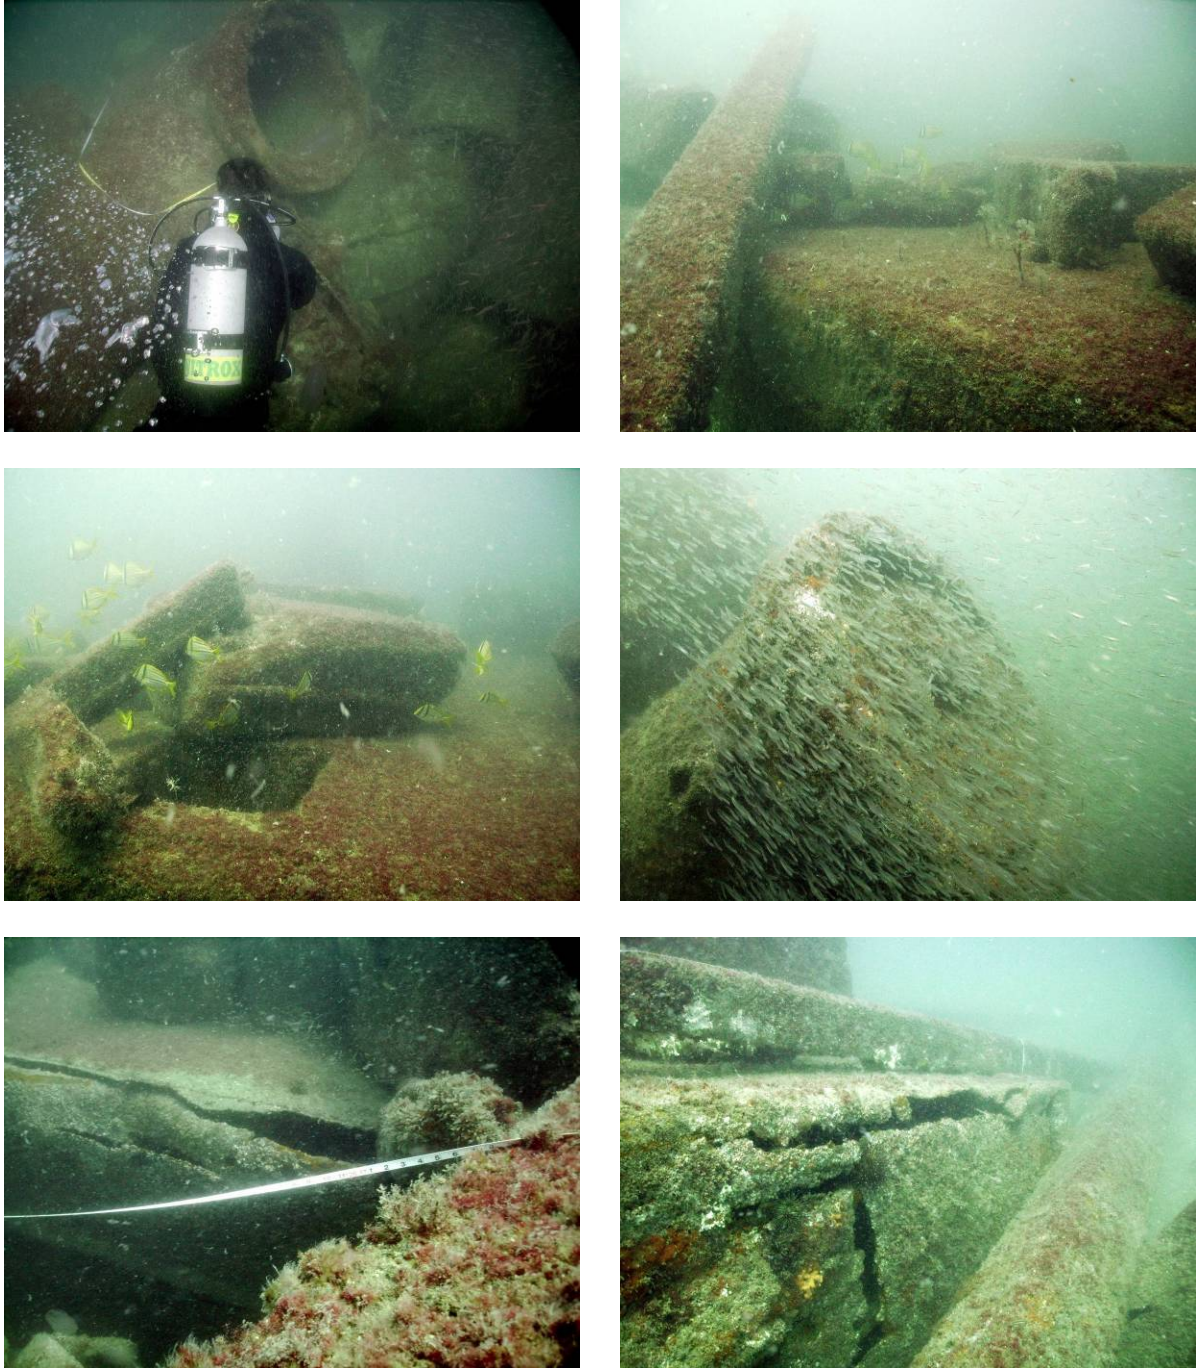
Figure 7. May 2008 Underwater Photographs of Civic Center Reef

The last two photographs in Figure 7 show the tears in the steel hull, that provide access for water flow and transit of marine life. These tears were probably initiated by the impact of the concrete materials deployed on top of the barge, and have increased slowly in their numbers and sizes since the summer 2007 inspections.

The Sterling Barge assisted in creating the high vertical relief of this reef, and the barge's rectangular shape and raked ends provide good navigation references for divers and underwater surveys. The concrete materials placed on top of and alongside of the barge provide an abundance of habitat both within and between the materials. The long-term corrosion of the barge will eventually result in some loss of the vertical relief, but that is not expected for several years due to the thickness of the steel.

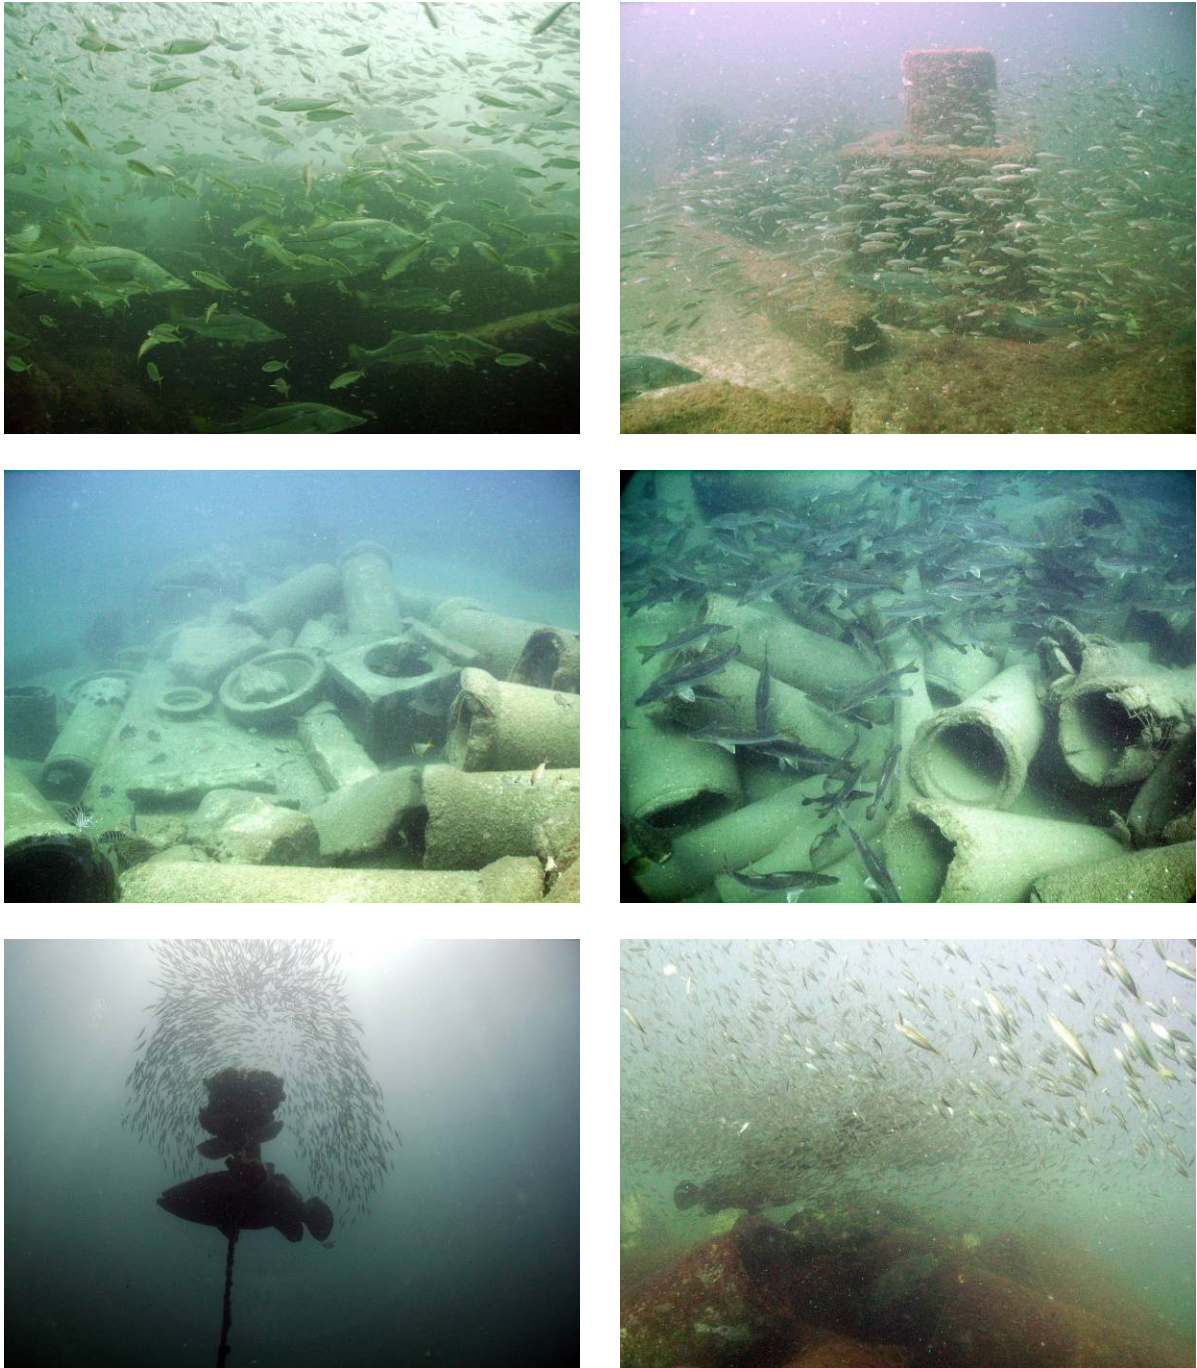
Figure 8. June 2007 Underwater Photographs of Civic Center Reef

Figure 8 shows underwater photographs taken in June 2007, with better visibility than during the 2008 monitoring. Larger portions of the reef can be seen, with abundant snook, and large Goliath Groupers with baitfish. The subsurface buoy at the east end of the reef often attracts fish, as shown in Figure 8.
