**2006 Annual Monitoring for the
2005 Artificial Reef Deployments of the
Concrete RRties and FPL Materials**

St. Lucie County, FL

January 2007

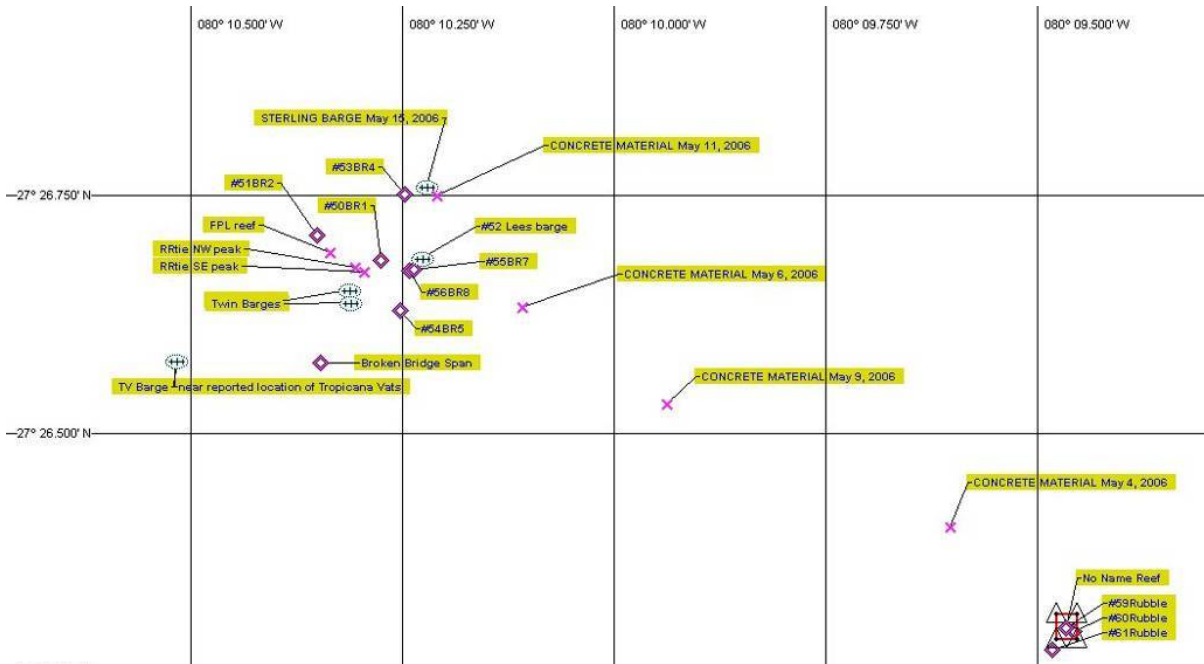
Figure 3. Locations of Historical and New Reef Deployments in Site #2
 2005 and 2006 deployments shown by red “x”; bridge spans by hollow red diamond; barges using traditional wreck symbols; and hollow black triangles for the No Name Reef.

Table 1 summarizes the two deployments that were made in 2005, with all of the other artificial reef sites in the northwest corner of Site #2 summarized in Table 3. These new deployments are filling in gaps between some of the older historical deployments, especially the concrete bridge spans, as shown in Figures 3 and 4.

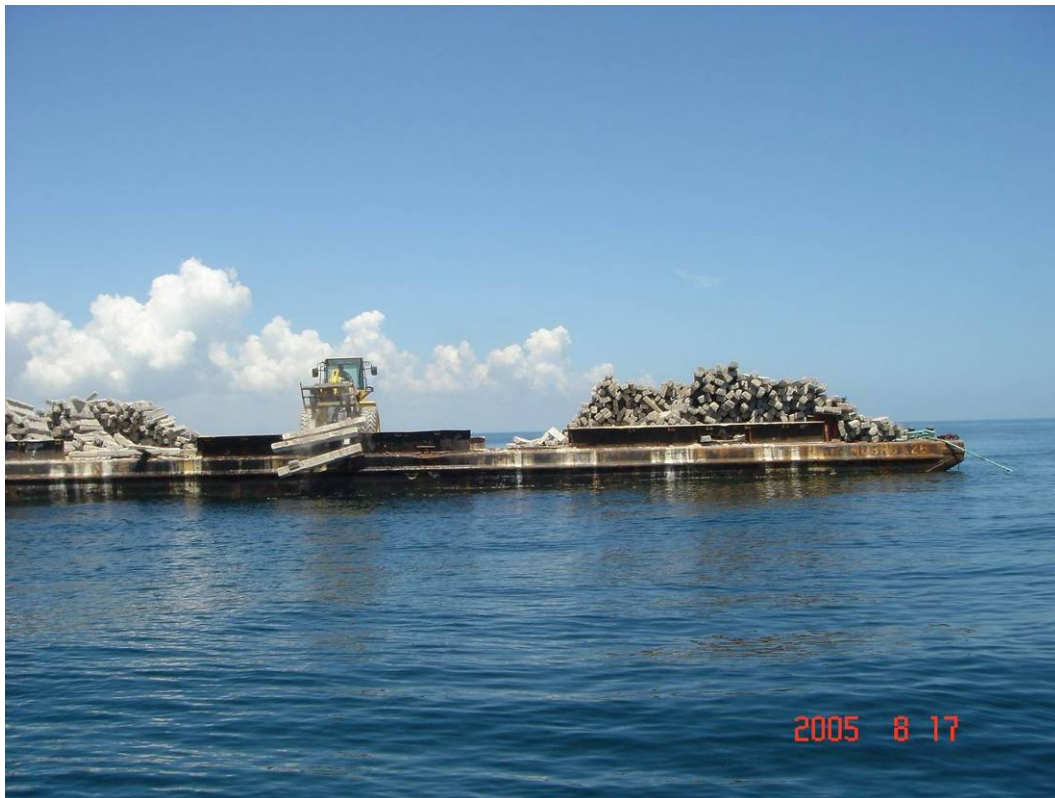
Figure 5. August 17, 2005 Deployment

Approximately 500 tons of concrete railroad ties were placed in one deployment from an anchored barge in 50 feet of ocean water. As shown in the photographs in Figures 5 and 6, a front end loader was used to deploy the RR ties from the barge. Approximately half of the units were deployed from the same point on one side of the barge, and the other half from the same point on the other side of the barge, so that two distinct peaks were constructed.

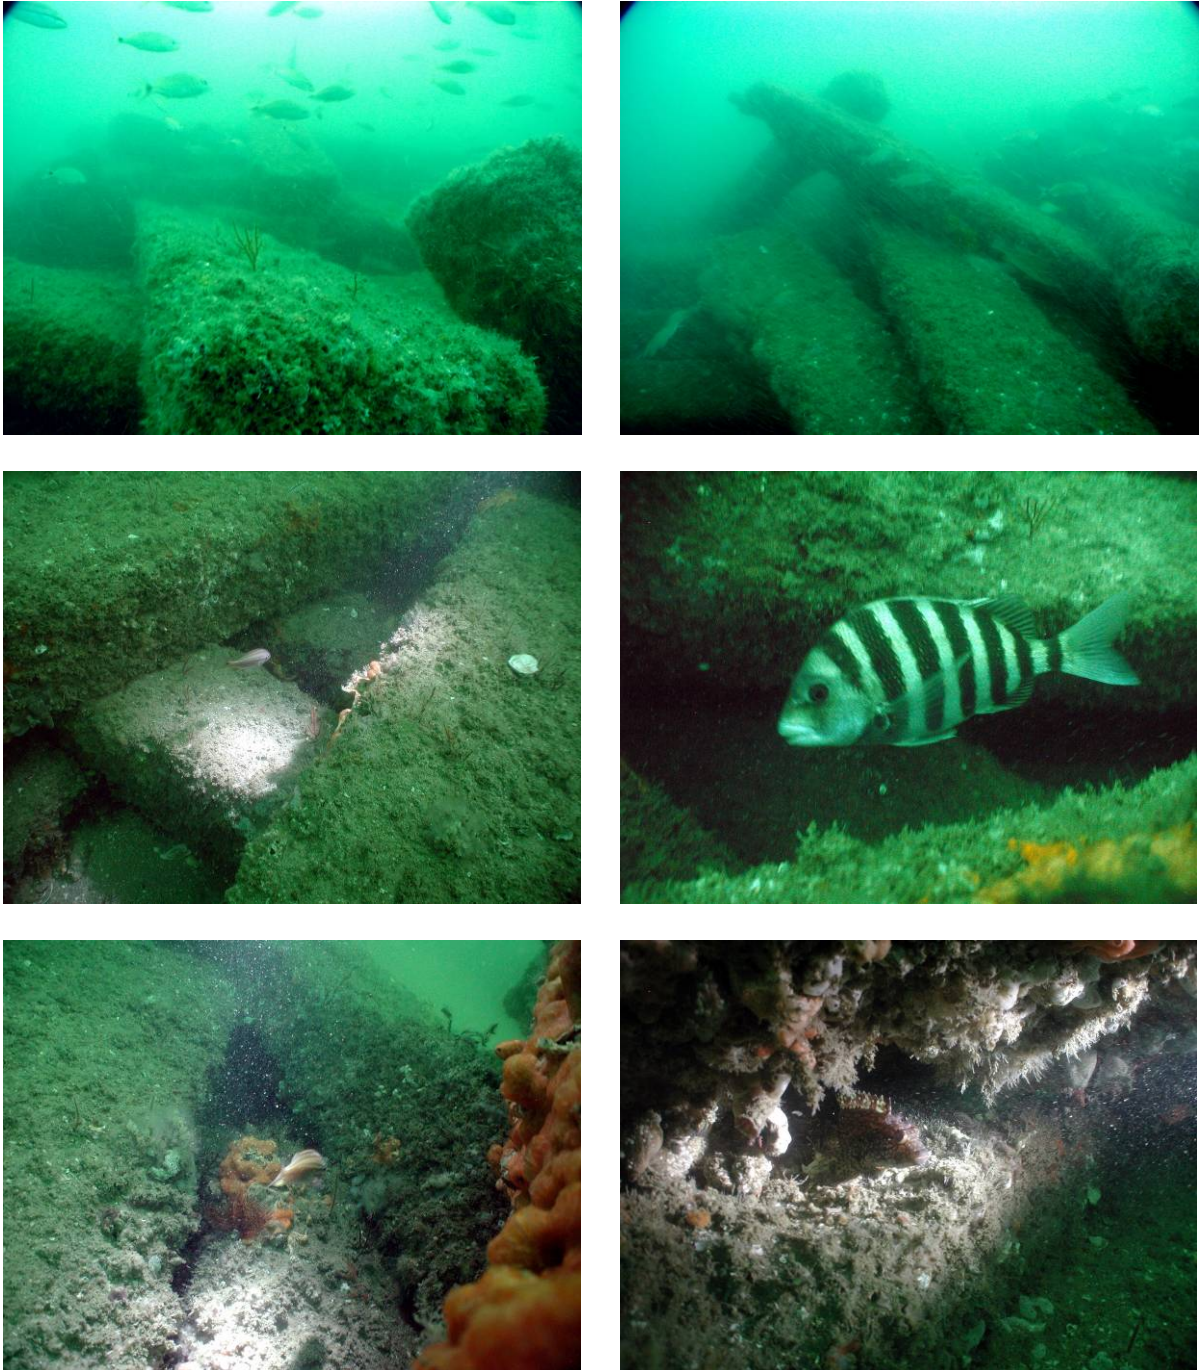
Figure 10. 2006 Photographs of RRtie Reef

Representative underwater photographs of the RRtie Reef taken in the fall of 2006 are shown in Figure 10. The visibility was not as good during the fall of 2006 as it was during the post-deployment dives in 2005, so that the photographs from 2006 are not as clear as in 2005. However, the benthic growth and fish inhabiting the RRtie Reef in 2006 was very impressive, as shown in Table 3 above and the following photographs.

The RRtie materials lie in a SE to NW orientation, with two distinct peaks of stacked RRties separated by a valley with some scattered ties. During the monitoring dives in the fall 2006, the maximum bottom depth at the RRtie Reef Site was measured as 50 feet, with the minimum depth at the reef crest measured as 37 feet, for a maximum reef height above the bottom of 13 feet. Little scouring or settlement of the reef was observed, and the materials were observed to be stable and covered with benthic growth, as shown in the photographs above.

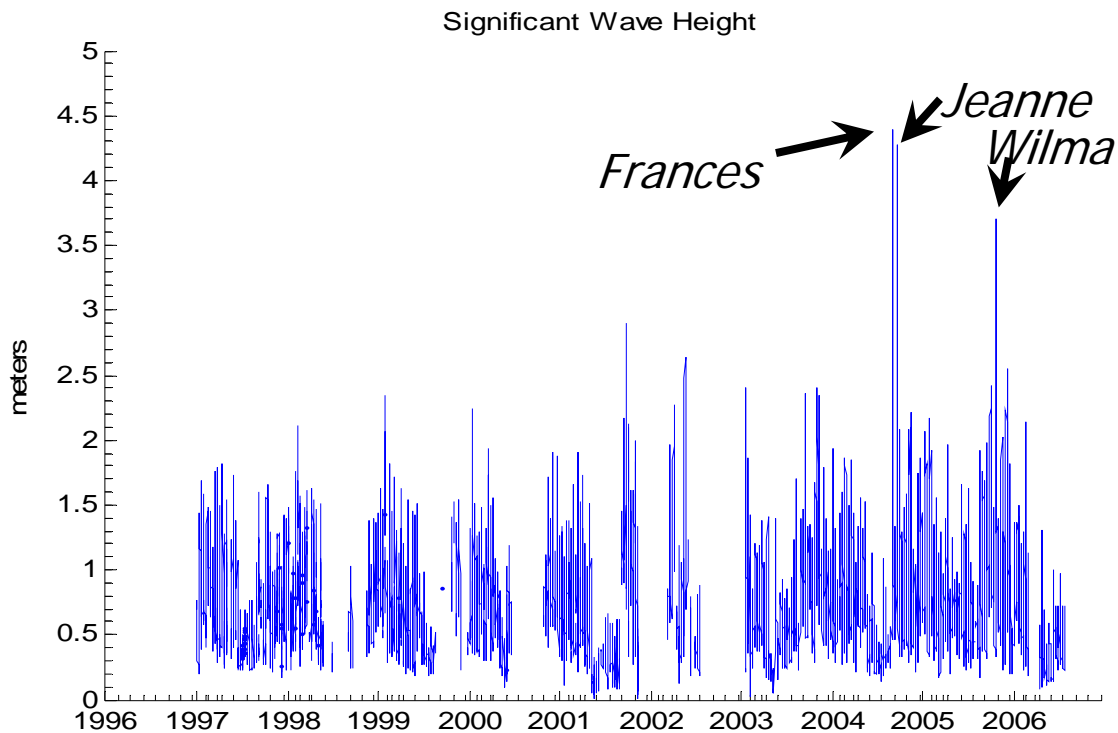
Figure 12. Significant Wave Heights Offshore Sebastian Inlet
(Harris and Flanary, 2007)

Although these two reefs were constructed during August and September of 2005 after the two major hurricanes in September 2004 (Frances and Jeanne), Hurricane Wilma affected this area during October 2005, shortly after these two new reefs were constructed. Wave data from the wave gage offshore Sebastian Inlet for the past 10 years is shown in Figure 12, which indicates that these three hurricanes produced the largest waves experienced by the central east coast of Florida during that time period. Wind and current speeds and directions measured offshore Sebastian Inlet during Hurricane Wilma are shown in Figure 13.

The 2006 annual monitoring performed in the fall of 2006 showed that these reefs remained stable, even after Hurricane Wilma. Some spreading out and settlement of the reef materials was observed, but no significant changes in the overall reef structures were observed, other than slight settlement and increases in the water depths above the reef crests, as summarized in Table 5.
